**Flood Control Project Maintenance
Levee Inspections****LMA District Cover Sheet****Spring 2011 Levee Inspection Results****Reclamation District No. 0900 West Sacramento**

Spring 2011 Levee Inspection Results

Reclamation District No. 0900 West Sacramento

| Waterway | | | Bank | Unit Miles |
|---|--|--|---|---|
| Unit No. 01 Sacramento River | | | Right | 7.84 |

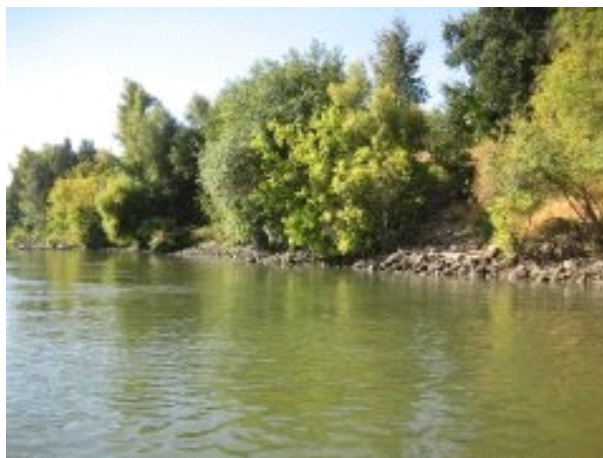
| pkazi_s_20110328_355.JPG | |

| LMIR No. | Levee Mile | | Category | Item | Location | Rating | Action/Comment | GPS Latitude/Longitude | | Issue No. Photo |
|---|---|---|---|---|---|---|--|---|---|---|
| 1 | 1.92 | 2.03 | Supplemental | USACE Erosion Survey | WS | U | Inspector Comments: 2009: no berm, 1.5:1 slope, tree hazards, holes, and slumping, sands and silts, 5.16 ft/s plus eddy currents [2009 SiteID:SAC_57-2_R] | 38.560492 ° -121.518417 ° | 38.559019 ° -121.517150 ° | 29 Y |

| 2009: no berm, 1.5:1 slope, tree hazards, holes, and slumping, sands and silts, 5.16 ft/s plus eddy currents [2009 SiteID:SAC_57-2_R] | |

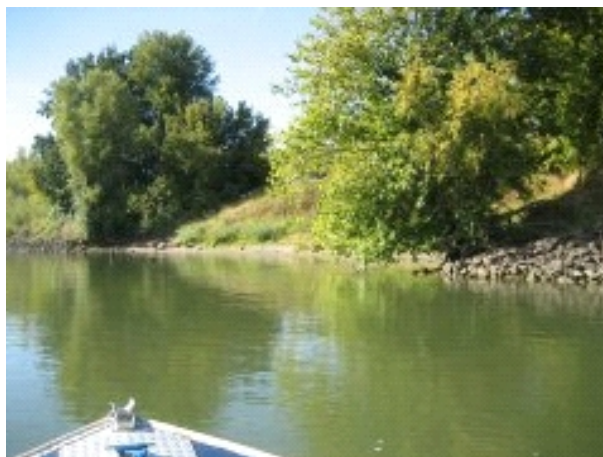
| pkazi_s_20110328_356.JPG | |

| LMIR No. | Levee Mile | | Category | Item | Location | Rating | Action/Comment | GPS Latitude/Longitude | | Issue No. Photo |
|---|---|---|---|---|---|---|--|---|---|---|
| 3 | 2.08 | 2.12 | Supplemental | USACE Erosion Survey | WS | U | Inspector Comments: 2009: no berm, 2:1 slope, tree hazards and seepage, sands and silts, 5.02 ft/s plus eddy currents [2009 SiteID:SAC_57-0_R] | 38.558239 ° -121.516736 ° | 38.557750 ° -121.516567 ° | 30 Y |

| 2009: no berm, 2:1 slope, tree hazards and seepage, sands and silts, 5.02 ft/s plus eddy currents [2009 SiteID:SAC_57-0_R] | |

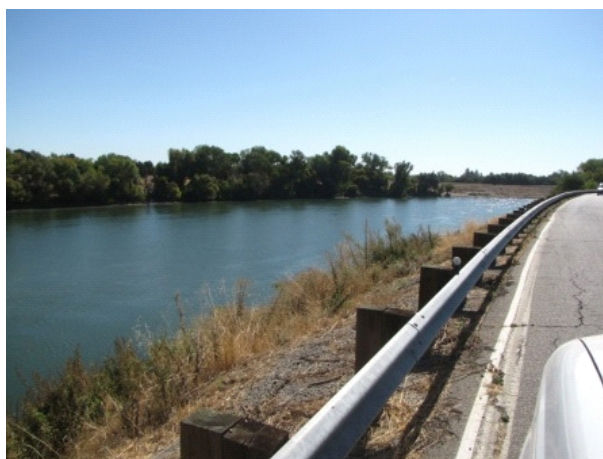
| pkazi_s_20110328_354.jpg | |

| View of vegetation within the top 20' of the waterward slope looking downstream. | |

| Waterway | | | | | | Bank | Unit Miles | Inspection Start/End | Inspector | |
|---|---|---|---|---|---|---|---|---|---|---|
| 18 | 2.90 | 2.90 | Earthen Levee | Vegetation | WS | M | Remove the wild growth other than native grasses from the levee slopes. | 38.546783 ° -121.512878 ° | 38.546783 ° -121.512878 ° | 11 Y |

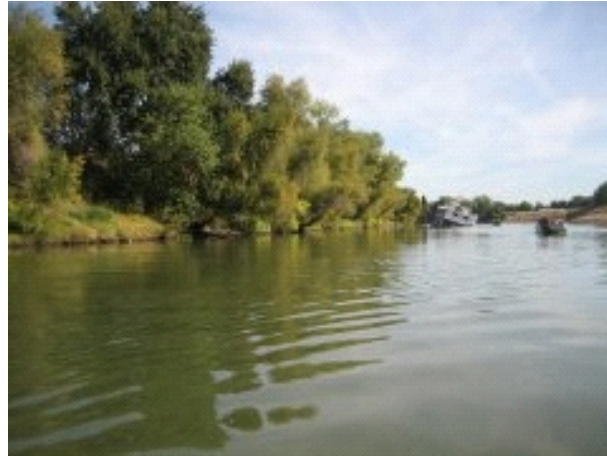
| pkazi_s_20110328_357.JPG | |

| Waterway | | | | | | Bank | Unit Miles | Inspection Start/End | Inspector | |
|---|---|---|---|---|---|---|---|---|---|---|
| 20 | 3.34 | 3.46 | Supplemental | USACE Erosion Survey | WS | U | Inspector Comments: 2009: no berm, 1:1 slope, tree hazards, holes, slumping, and seepage, sands and silts, 4.46 ft/s [2009 SiteID:SAC_55-7_R] | 38.540333 ° -121.513889 ° | 38.538969 ° -121.515456 ° | 31 Y |

| 2009: no berm, 1:1 slope, tree hazards, holes, slumping, and seepage, sands and silts, 4.46 ft/s [2009 SiteID:SAC_55-7_R] | |

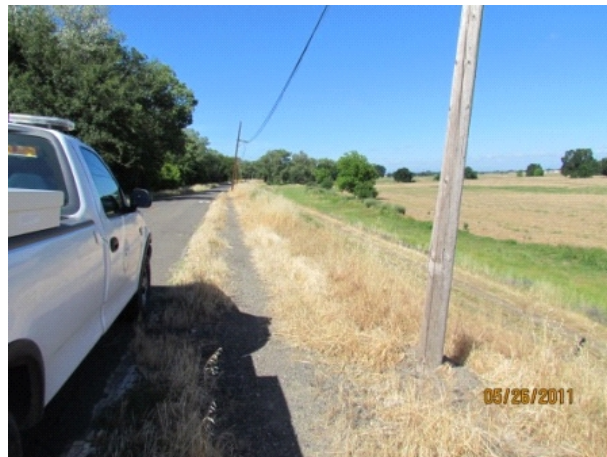
| pkazi_s_20110527_637.jpg | |

| Annual vegetation control on the landside of the levee. The picture is taken from crown looking downstream. | |

| Waterway | | | | | | Bank | Unit Miles | Inspection Start/End | Inspector | |
|---|---|---|---|---|---|---|---|---|---|---|
| 27 | 3.57 | 4.26 | Earthen Levee | Vegetation | LS | M | Control annual grass and weeds on the levee slopes and easements. | 38.538350 ° -121.517341 ° | 38.533459 ° -121.528238 ° | 2 Y |

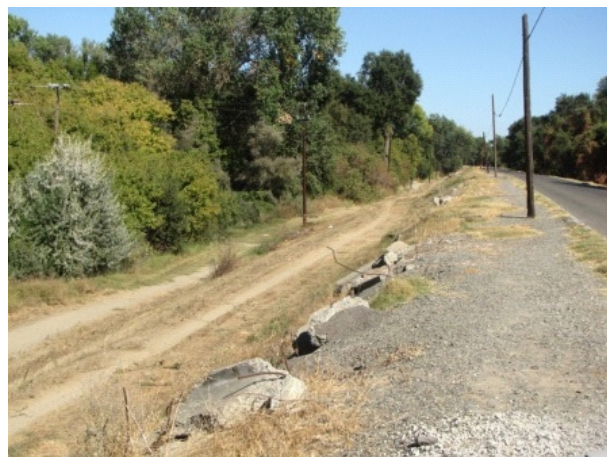
| pkazi_s_20110328_359.jpg | |

| Waterway | | | | | | Bank | Unit Miles | Inspection Start/End | Inspector | |
|---|---|---|---|---|---|---|---|---|---|---|
| 29 | 4.11 | 4.11 | Earthen Levee | Encroachments | LS | M | Debris Inspector Comments: Concrete debris with metal posing a safety risk. | 38.534364 ° -121.526051 ° | 38.534364 ° -121.526051 ° | 54 Y |

| View of concrete debris with metal looking upstream. | |

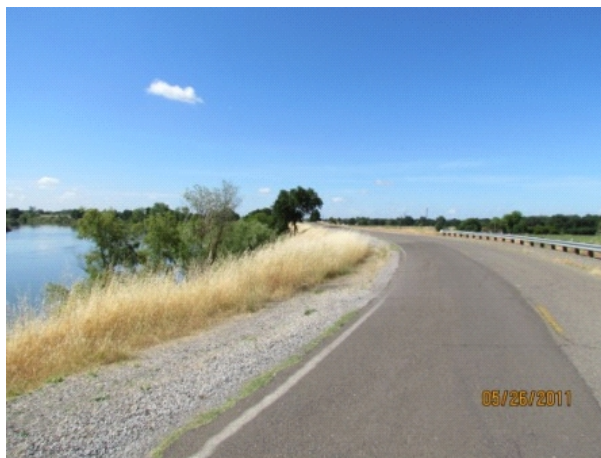
pkazi_s_20110527_638.jpg

Vegetation on the waterside of the levee looking downstream.

| Waterway | | | | | | Bank | Unit Miles | Inspection Start/End | Inspector | |
|---|---|---|---|---|---|---|---|---|---|---|
| 31 | 4.48 | 4.83 | Earthen Levee | Vegetation | WS | M | Control annual grass and weeds on the levee slopes and easements. | 38.531357 ° -121.531445 ° | 38.526524 ° -121.531097 ° | 4 Y |

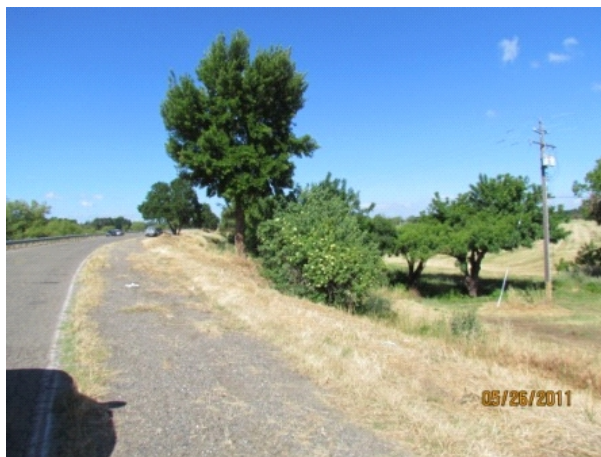
pkazi_s_20110527_639.jpg

| Waterway | | | | | | Bank | Unit Miles | Inspection Start/End | Inspector | |
|---|---|---|---|---|---|---|--|---|---|---|
| 37 | 5.53 | 5.53 | Earthen Levee | Vegetation | LS M | Elderberries are blocking visibility and flood fight capability. | | 38.518988 ° -121.527738 ° | 38.518988 ° -121.527738 ° | 958 Y |

Elderberry on the landside of the levee. The picture was taken from the crown looking downstream.

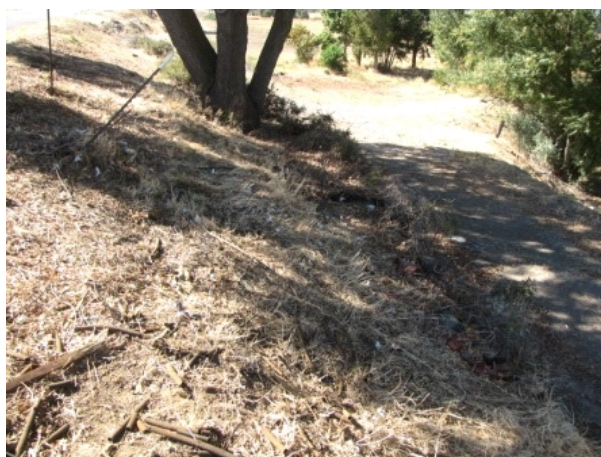
pkazi_s_20110328_358.jpg

| Waterway | | | | | | Bank | Unit Miles | Inspection Start/End | Inspector | |
|---|---|---|---|---|---|---|--|---|---|---|
| 40 | 5.59 | 5.59 | Earthen Levee | Encroachments | LS PO | Buildings | Inspector Comments: Retaining wall and vegetation along the edge of the landward ramp. | 38.518561 ° -121.528756 ° | 38.518561 ° -121.528756 ° | 53 Y |

View of a retaining wall and vegetation along the edge of the ramp looking downstream.

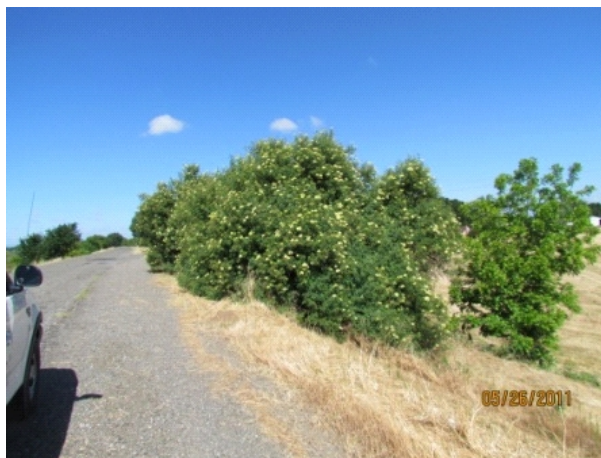
pkazi_s_20110527_640.jpg

| Waterway | | | | | | Bank | Unit Miles | Inspection Start/End | Inspector | |
|---|---|---|---|---|---|---|--|---|---|---|
| 41 | 5.97 | 5.98 | Earthen Levee | Vegetation | LS M | Elderberries are blocking visibility and flood fight capability. | | 38.517952 ° -121.535672 ° | 38.517948 ° -121.535857 ° | 25 Y |

Elderberry located on the landside of the levee obstructing the view. The picture was taken from the crown looking downstream.

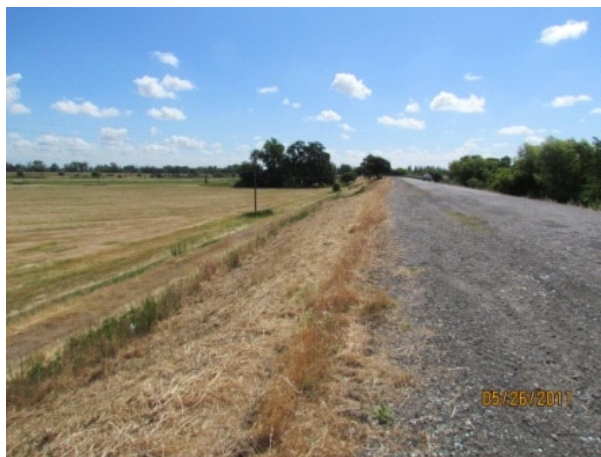
pkazi_s_20110527_641.jpg

Vegetation control complies with standards on the landside of the levee. The picture was taken from the crown looking upstream.

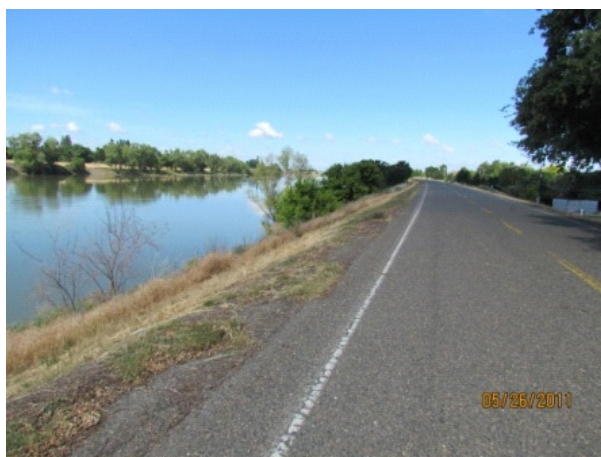
pkazi_s_20110527_642.jpg

Vegetation complies with standards on the waterside of the levee. The picture was taken from the crown looking downstream.

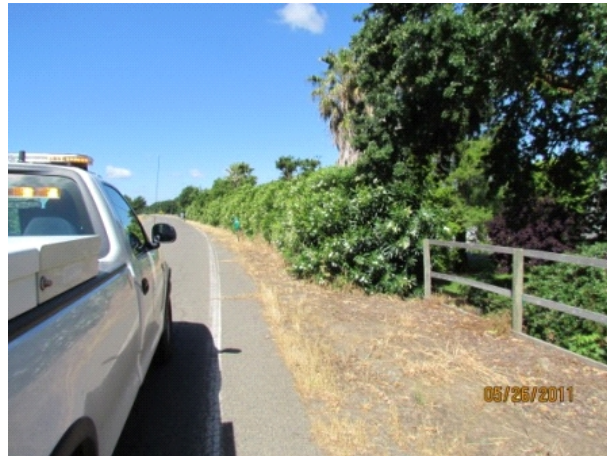
pkazi_s_20110527_643.jpg

| Waterway | | | | | | Bank | Unit Miles | Inspection Start/End | Inspector | |
|---|---|---|---|---|---|---|--|---|---|---|
| 44 | 6.57 | 6.63 | Earthen Levee | Encroachments | LS PO | Landscaping | | 38.516657 ° -121.546643 ° | 38.516421 ° -121.547575 ° | 10 Y |

Landscaping was obstructing the view on the landside of the levee. The picture was taken from the crown looking downstream.

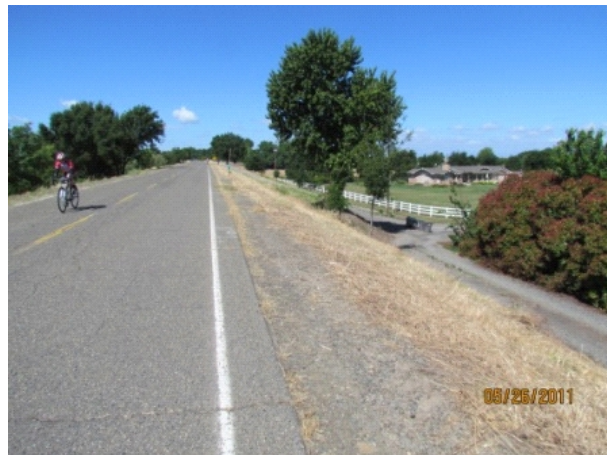
pkazi_s_20110527_644.jpg

Vegetation and trees complied with standards on the landside of the levee. The picture was taken from the crown looking downstream.

| Waterway | | | | | | Bank | Unit Miles | Inspection Start/End | Inspector | |
|---|---|---|---|---|---|---|--|---|---|---|
| 46 | 6.74 | 6.74 | Earthen Levee | Trim / Thin Trees | LS A | Trim trees to at least five feet above ground level. | | 38.515841 ° -121.549510 ° | 38.515841 ° -121.549510 ° | 6 Y |

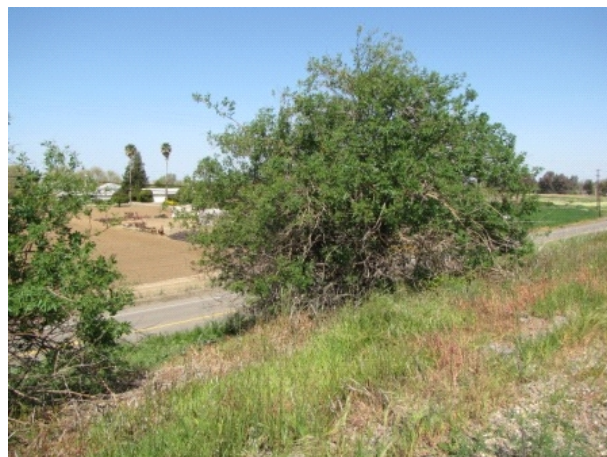
pkazi_s_20110328_353.jpg

| Waterway | | | | | | Bank | Unit Miles | Inspection Start/End | Inspector | |
|---|---|---|---|---|---|---|--|---|---|---|
| 48 | 7.27 | 7.27 | Earthen Levee | Vegetation | LS M | Elderberries are blocking visibility and flood fight capability. | | 38.510613 ° -121.555969 ° | 38.510613 ° -121.555969 ° | 7 Y |

View of elderberries blocking visibility on the landward slope looking upstream.

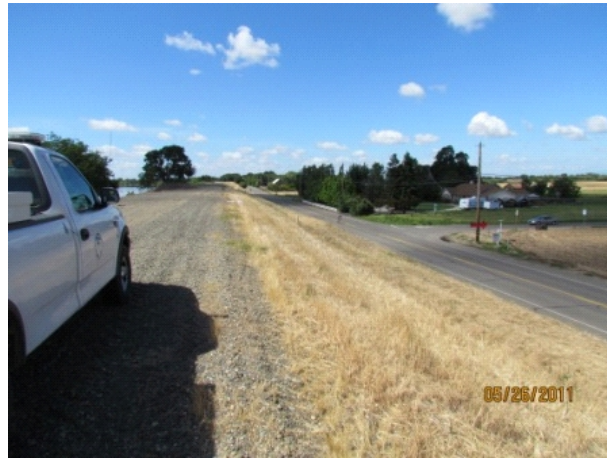
pkazi_s_20110527_645.jpg

Vegetation complies with standards on the landside of the levee. The picture was taken from the crown looking downstream.

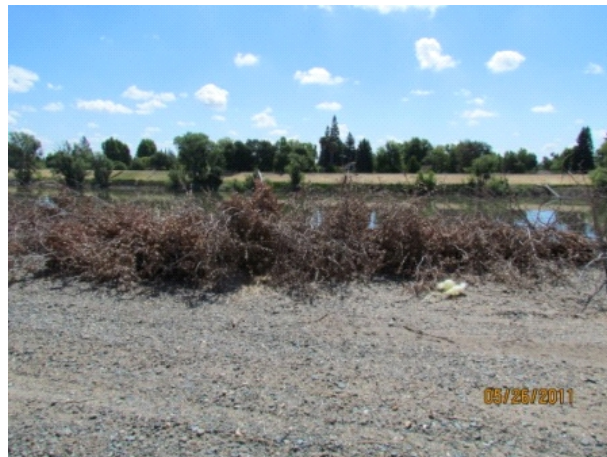
pkazi_s_20110527_646.jpg

| Waterway | | | | | | Bank | Unit Miles | Inspection Start/End | Inspector | |
|---|---|---|---|---|---|---|--|---|---|---|
| 50 | 7.33 | 7.33 | Earthen Levee | Encroachments | WS M | Prunings | | 38.509748 ° -121.556426 ° | 38.509748 ° -121.556426 ° | 14 Y |

Pruning was found on the waterside of the levee. The picture was taken from the crown looking towards the river.

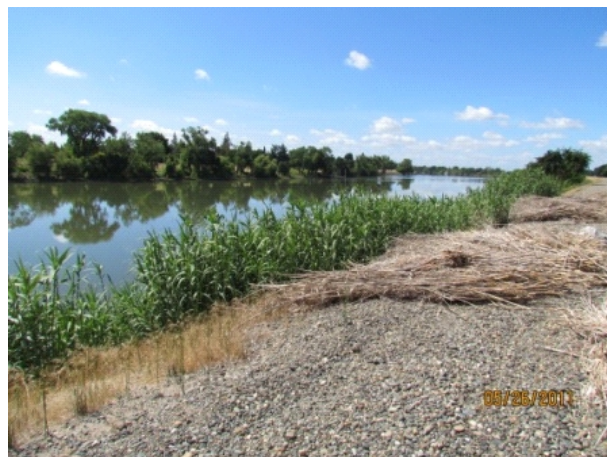
pkazi_s_20110527_647.jpg

| Waterway | | | | | | Bank | Unit Miles | Inspection Start/End | Inspector | |
|---|---|---|---|---|---|---|--|---|---|---|
| 51 | 7.50 | 7.50 | Earthen Levee | Vegetation | WS M | Remove the wild growth other than native grasses from the levee slopes. Inspector Comments: Arundo on the waterward slope. | | 38.507497 ° -121.557643 ° | 38.507497 ° -121.557643 ° | 12 Y |

Arrundo on the waterside slope of the levee. The picture was taken from the crown looking downstream.

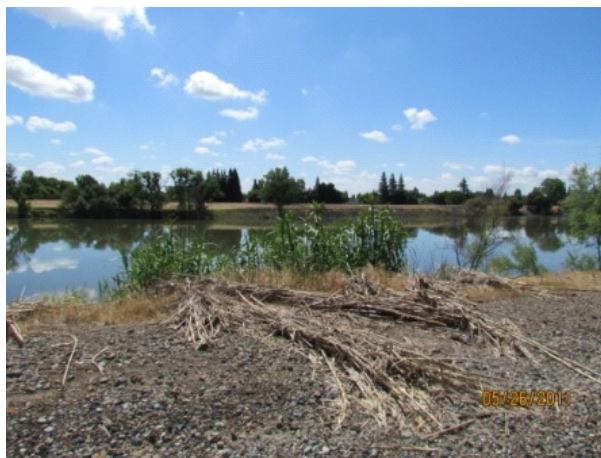
pkazi_s_20110527_648.jpg

| Waterway | | | | | | Bank | Unit Miles | Inspection Start/End | Inspector | |
|---|---|---|---|---|---|---|--|---|---|---|
| 52 | 7.81 | 7.81 | Earthen Levee | Vegetation | WS M | Remove the wild growth other than native grasses from the levee slopes. Inspector Comments: Arundo on the waterward slope. | | 38.503384 ° -121.559836 ° | 38.503384 ° -121.559836 ° | 13 Y |

Arrundo on the waterside slope of the levee. The picture was taken from the crown looking towards the river.

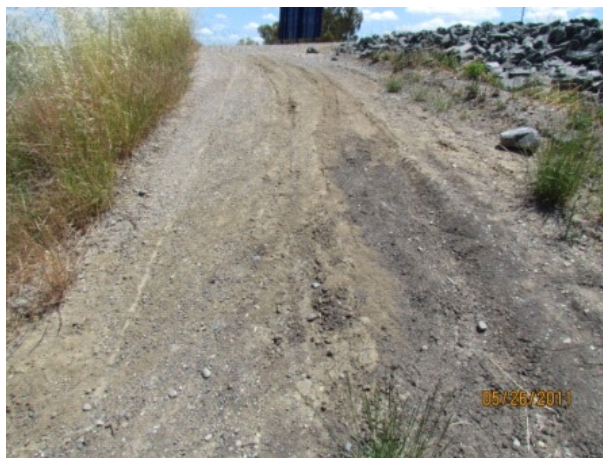
pkazi_s_20110527_652.jpg

| Waterway | | | | | | | Bank | Unit Miles | Inspection Start/End | Inspector |
|---|---|---|---|---|---|---|--|---|---|---|
| 3 | 0.95 | 0.95 | Earthen Levee | Cracking | WS | W | Monitor and have inspected by geotechnical engineer. | 38.574250 ° -121.581520 ° | 38.574250 ° -121.581520 ° | 9 Y |

No cracking bigger than 6 inches was observed in the area, but due to the soil condition during summer time it may appear again. The picture was taken from the crown looking downstream.

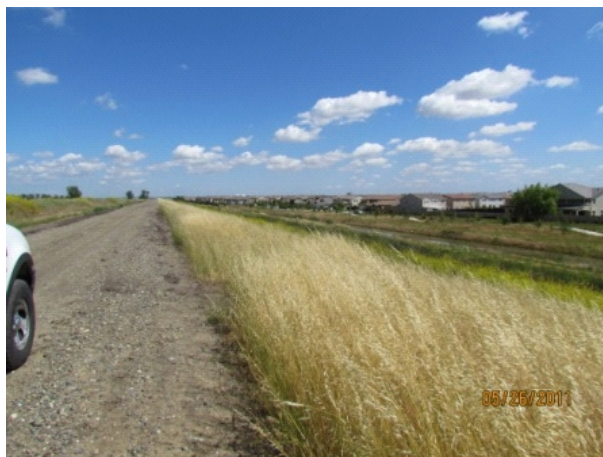
pkazi_s_20110527_651.jpg

Vegetation on the landside of the levee. The picture was taken from the crown looking downstream.

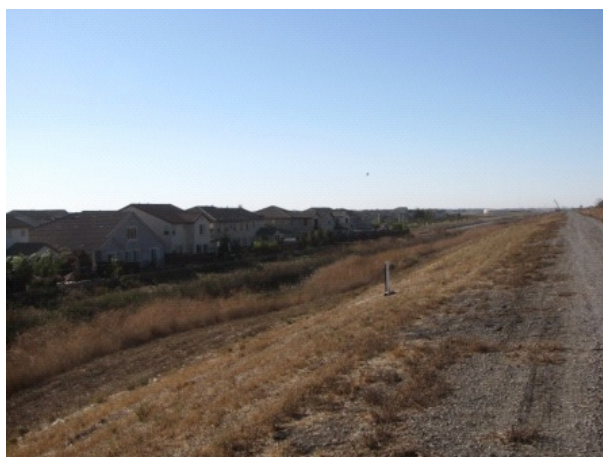
pkazi_s_20110328_365.jpg

View of vegetation along the toe adjacent to the ditch looking downstream.

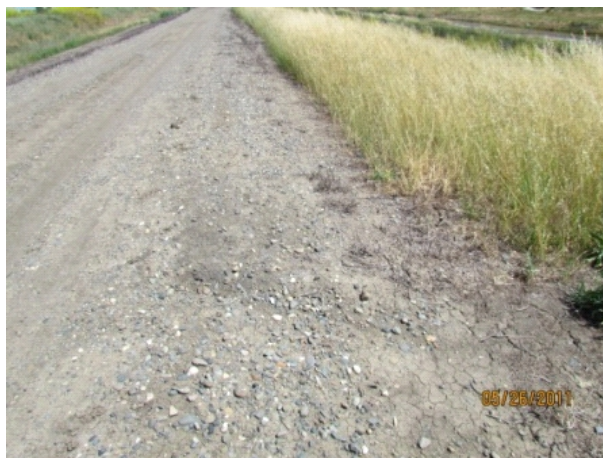
pkazi_s_20110527_650.jpg

| Waterway | | | | | | | Bank | Unit Miles | Inspection Start/End | Inspector |
|---|---|---|---|---|---|---|--|---|---|---|
| 12 | 4.37 | 4.37 | Earthen Levee | Slope Stability | CR | A | Repair slope instability. | 38.524939 ° -121.582120 ° | 38.524939 ° -121.582120 ° | 8 Y |

Slope stability on the crown found on last inspection was fixed. The picture was taken from the crown looking downstream.

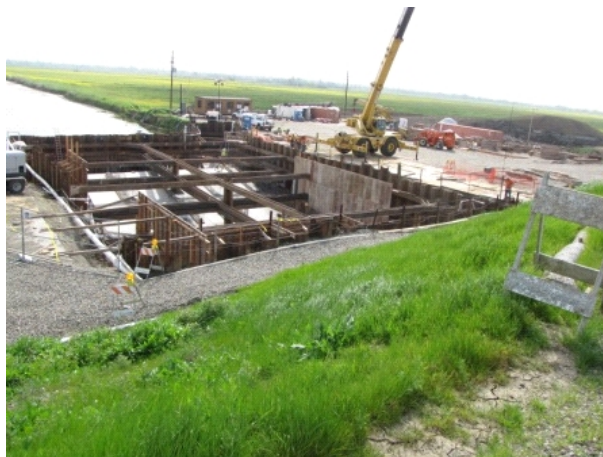
pkazi_s_20110328_363.jpg

| Waterway | | | | | | Bank | Unit Miles | Inspection Start/End | Inspector | |
|---|---|---|---|---|---|---|--|---|---|---|
| 16 | 4.96 | 4.96 | Earthen Levee | Encroachments | LS | PO | Buildings Inspector Comments: Ongoing pump station replacement project underway, permit #18116. | 38.516465 ° -121.582225 ° | 38.516465 ° -121.582225 ° | 12 Y |

View of the open pit and construction activity on a new pump station on the landward side of the levee.

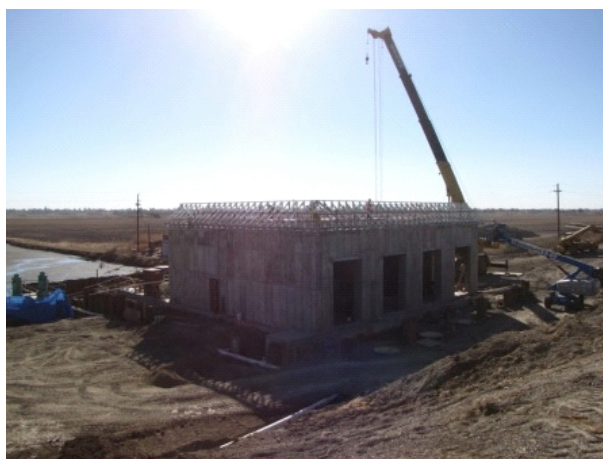
pkazi_s_20110328_364.jpg

View of construction as of fall 2010.

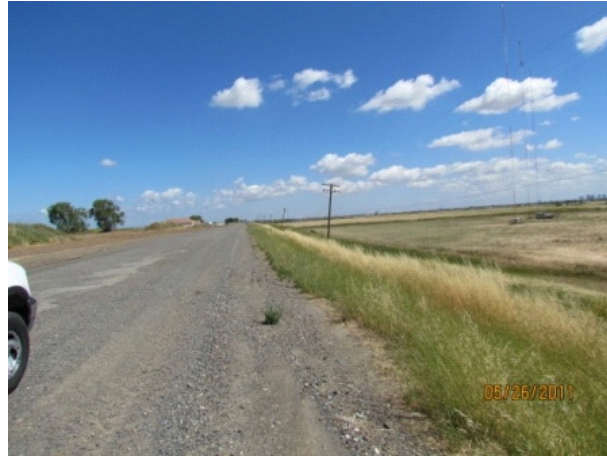
pkazi_s_20110527_649.jpg

Vegetation on the landside of the levee. The picture was taken from the crown looking downstream.
